Manhole Inspection Summary

Manhole # S37GG_041MH

Location Address: **428 PRESTON ST**

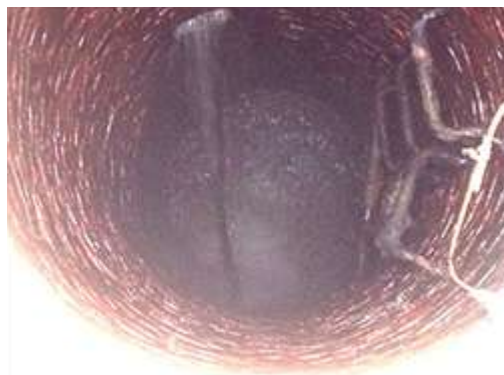
Top View

Corroded and missing steps. Evidence of surcharge.

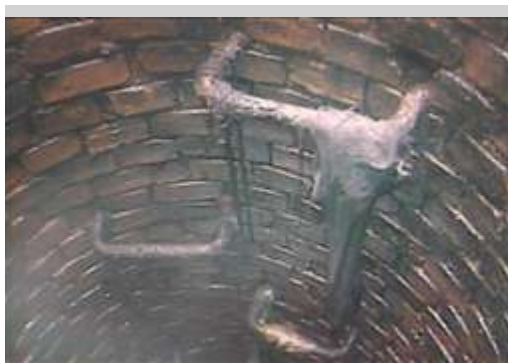
Evidence of surcharge

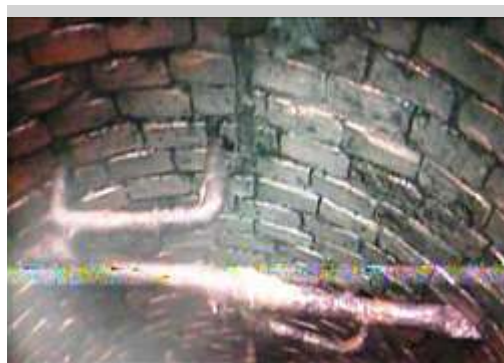
Pipes going through the MH

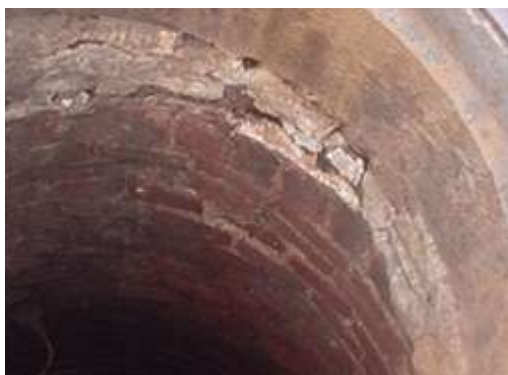
Defect

☒ **Leaks**

Condition: ☐ Sound ☐ Cracked ☐ Root Intrusion ☐ Loose Brick ☒ **Deteriorated**

Infiltration: ☐ None ☒ **Joint** ☐ Cracks ☒ **Mortar** ☐ Roots ☐ Wall

Frame leaks. Adjustment deterioration and infiltration.

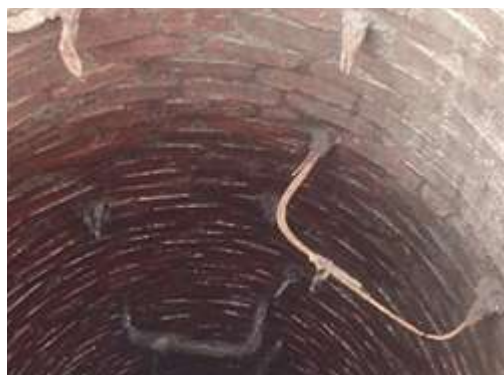
Defect

Count: **13** Missing: **4** ☒ **Corroded**

Corroded and missing steps.

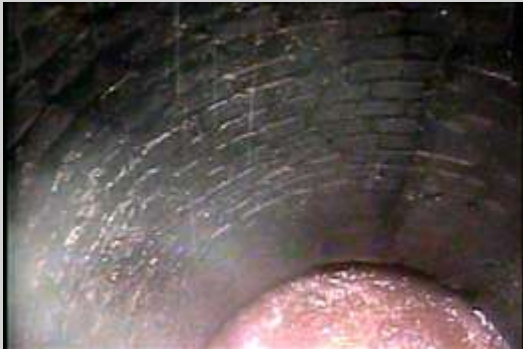
72 in. Circular Gravity Sewer Pipe Out @ 12 O'Clock

Pipe Material: **Unknown** ☐ Pipe Lined

Invert Depth: **30.51** (ft.) Flow Characteristics: **Slow**

Infiltration: **None** Pipe Seal Cond: **Unknown**

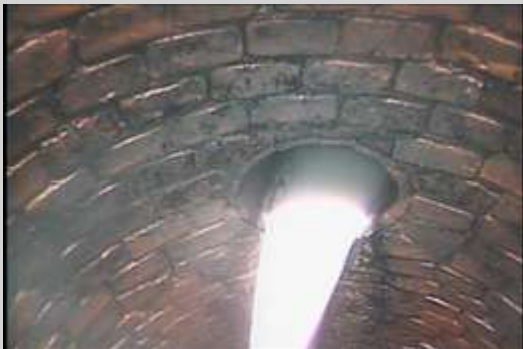
8 in. Circular Gravity Sewer Pipe In @ 1 O'Clock

Pipe Material: **Clay** ☐ Pipe Lined

Invert Depth: **14.02** (ft.) Flow Characteristics: **Fast**

Infiltration: **None** Pipe Seal Cond: **Unknown**

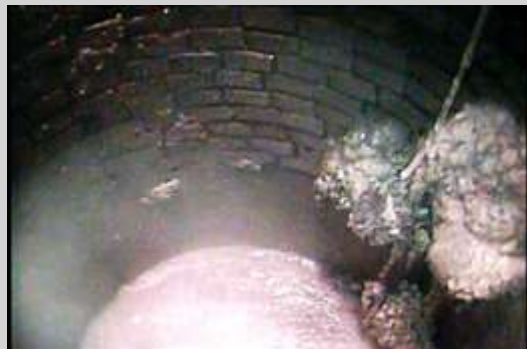
72 in. Circular Gravity Sewer

Pipe Material: **Unknown**

Invert Depth: **29.93** (ft.) Flow Characteristics: **Slow**

Infiltration: **None**
